UPPER WILSON POND DAM

NH 00202

PHASE I INSPECTION REPORT
NATIONAL DAM INSPECTION PROGRAM

AUGUST 1981

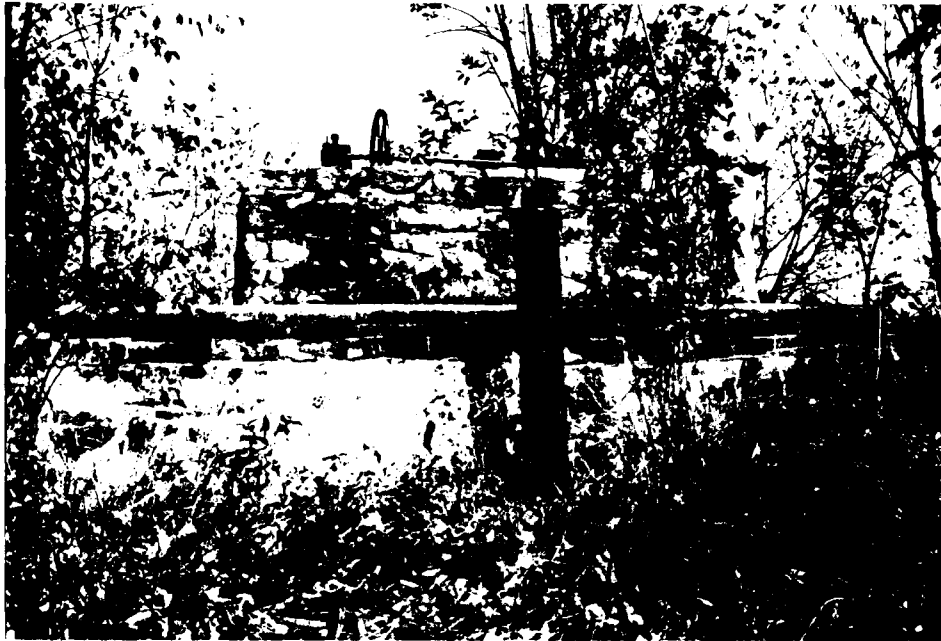
The head-gate operating mechanism is located on a double platform. The lower portion consists of concrete-faced stone masonry on its downstream end and sides, and cemented stone masonry on its upstream end. The upper portion consists of cemented stone masonry. Minor seepage is flowing through the lower platform concrete facing at the spillway crest elevation. There is considerable random cracking in the facing, with efflorescence, including minor exudation.

5. Downstream Side of Intake Structure and Gate Control Mechanism.

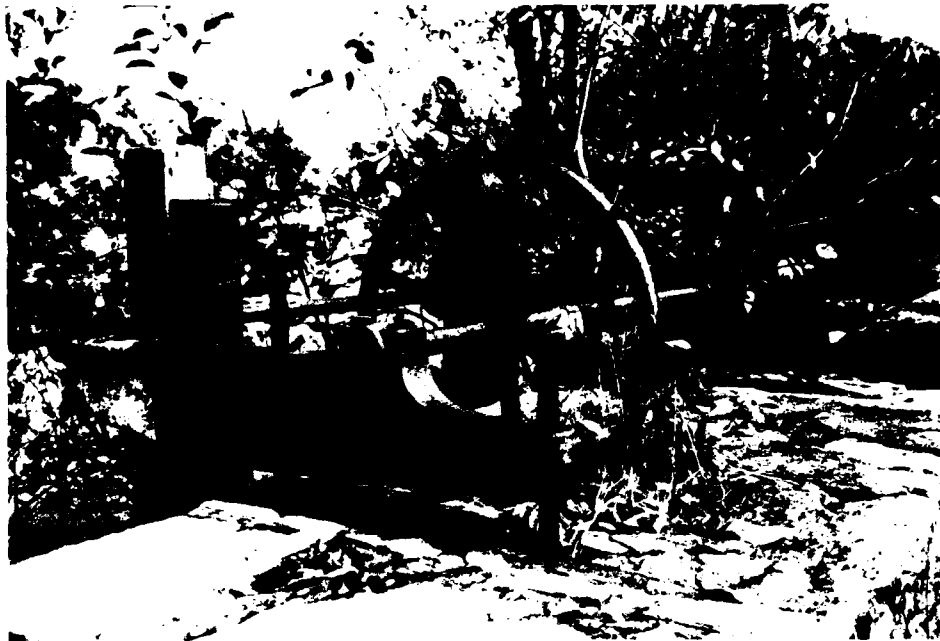
7. Detail of Gate Control Mechanism - Note Gate is not Operable

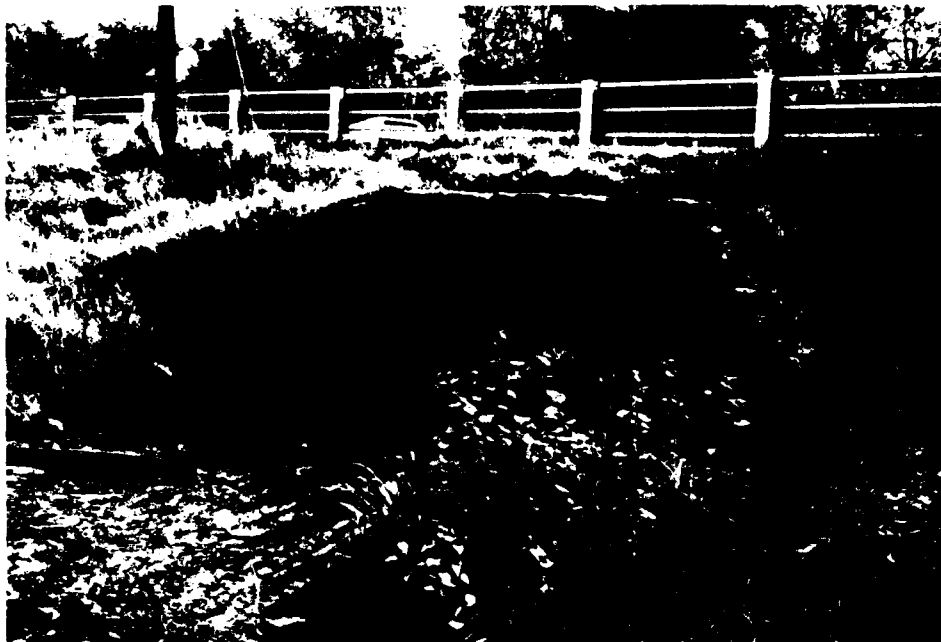
9. Culvert Approximately 50 Feet Downstream of Dam

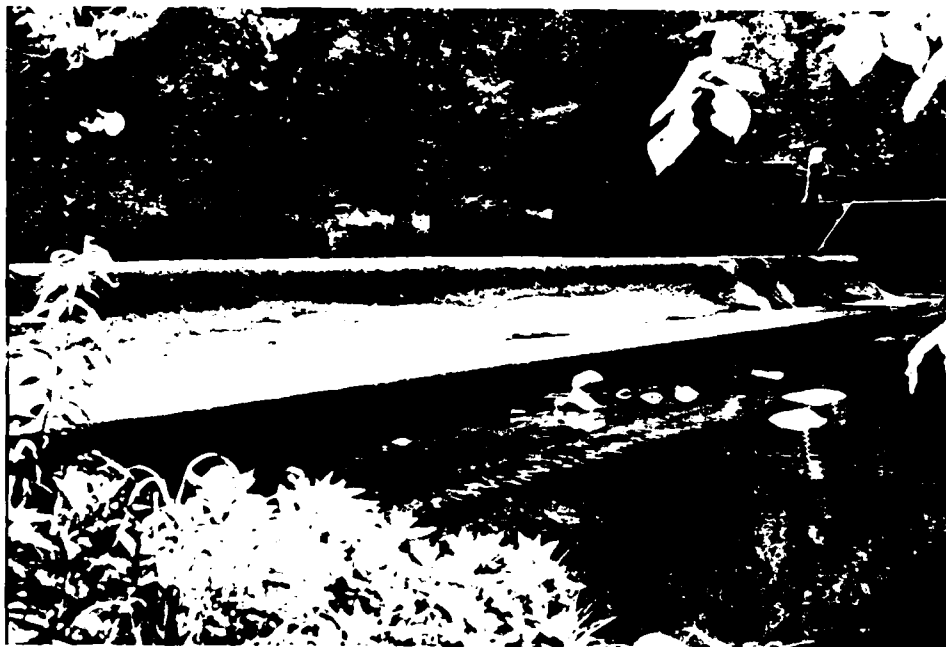
11. Overview of Diversion Structure on Branch River. Note: Flow to Upper Wilson Passes Through Gate at Left Abutment

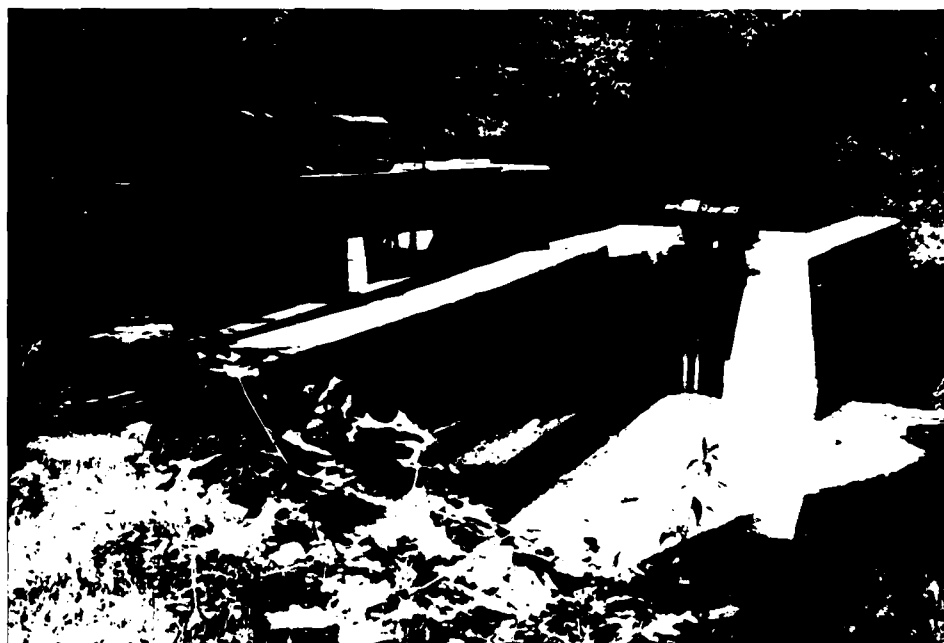
12. Gate Structure at Left Abutment of Diversion Structure
